77-643

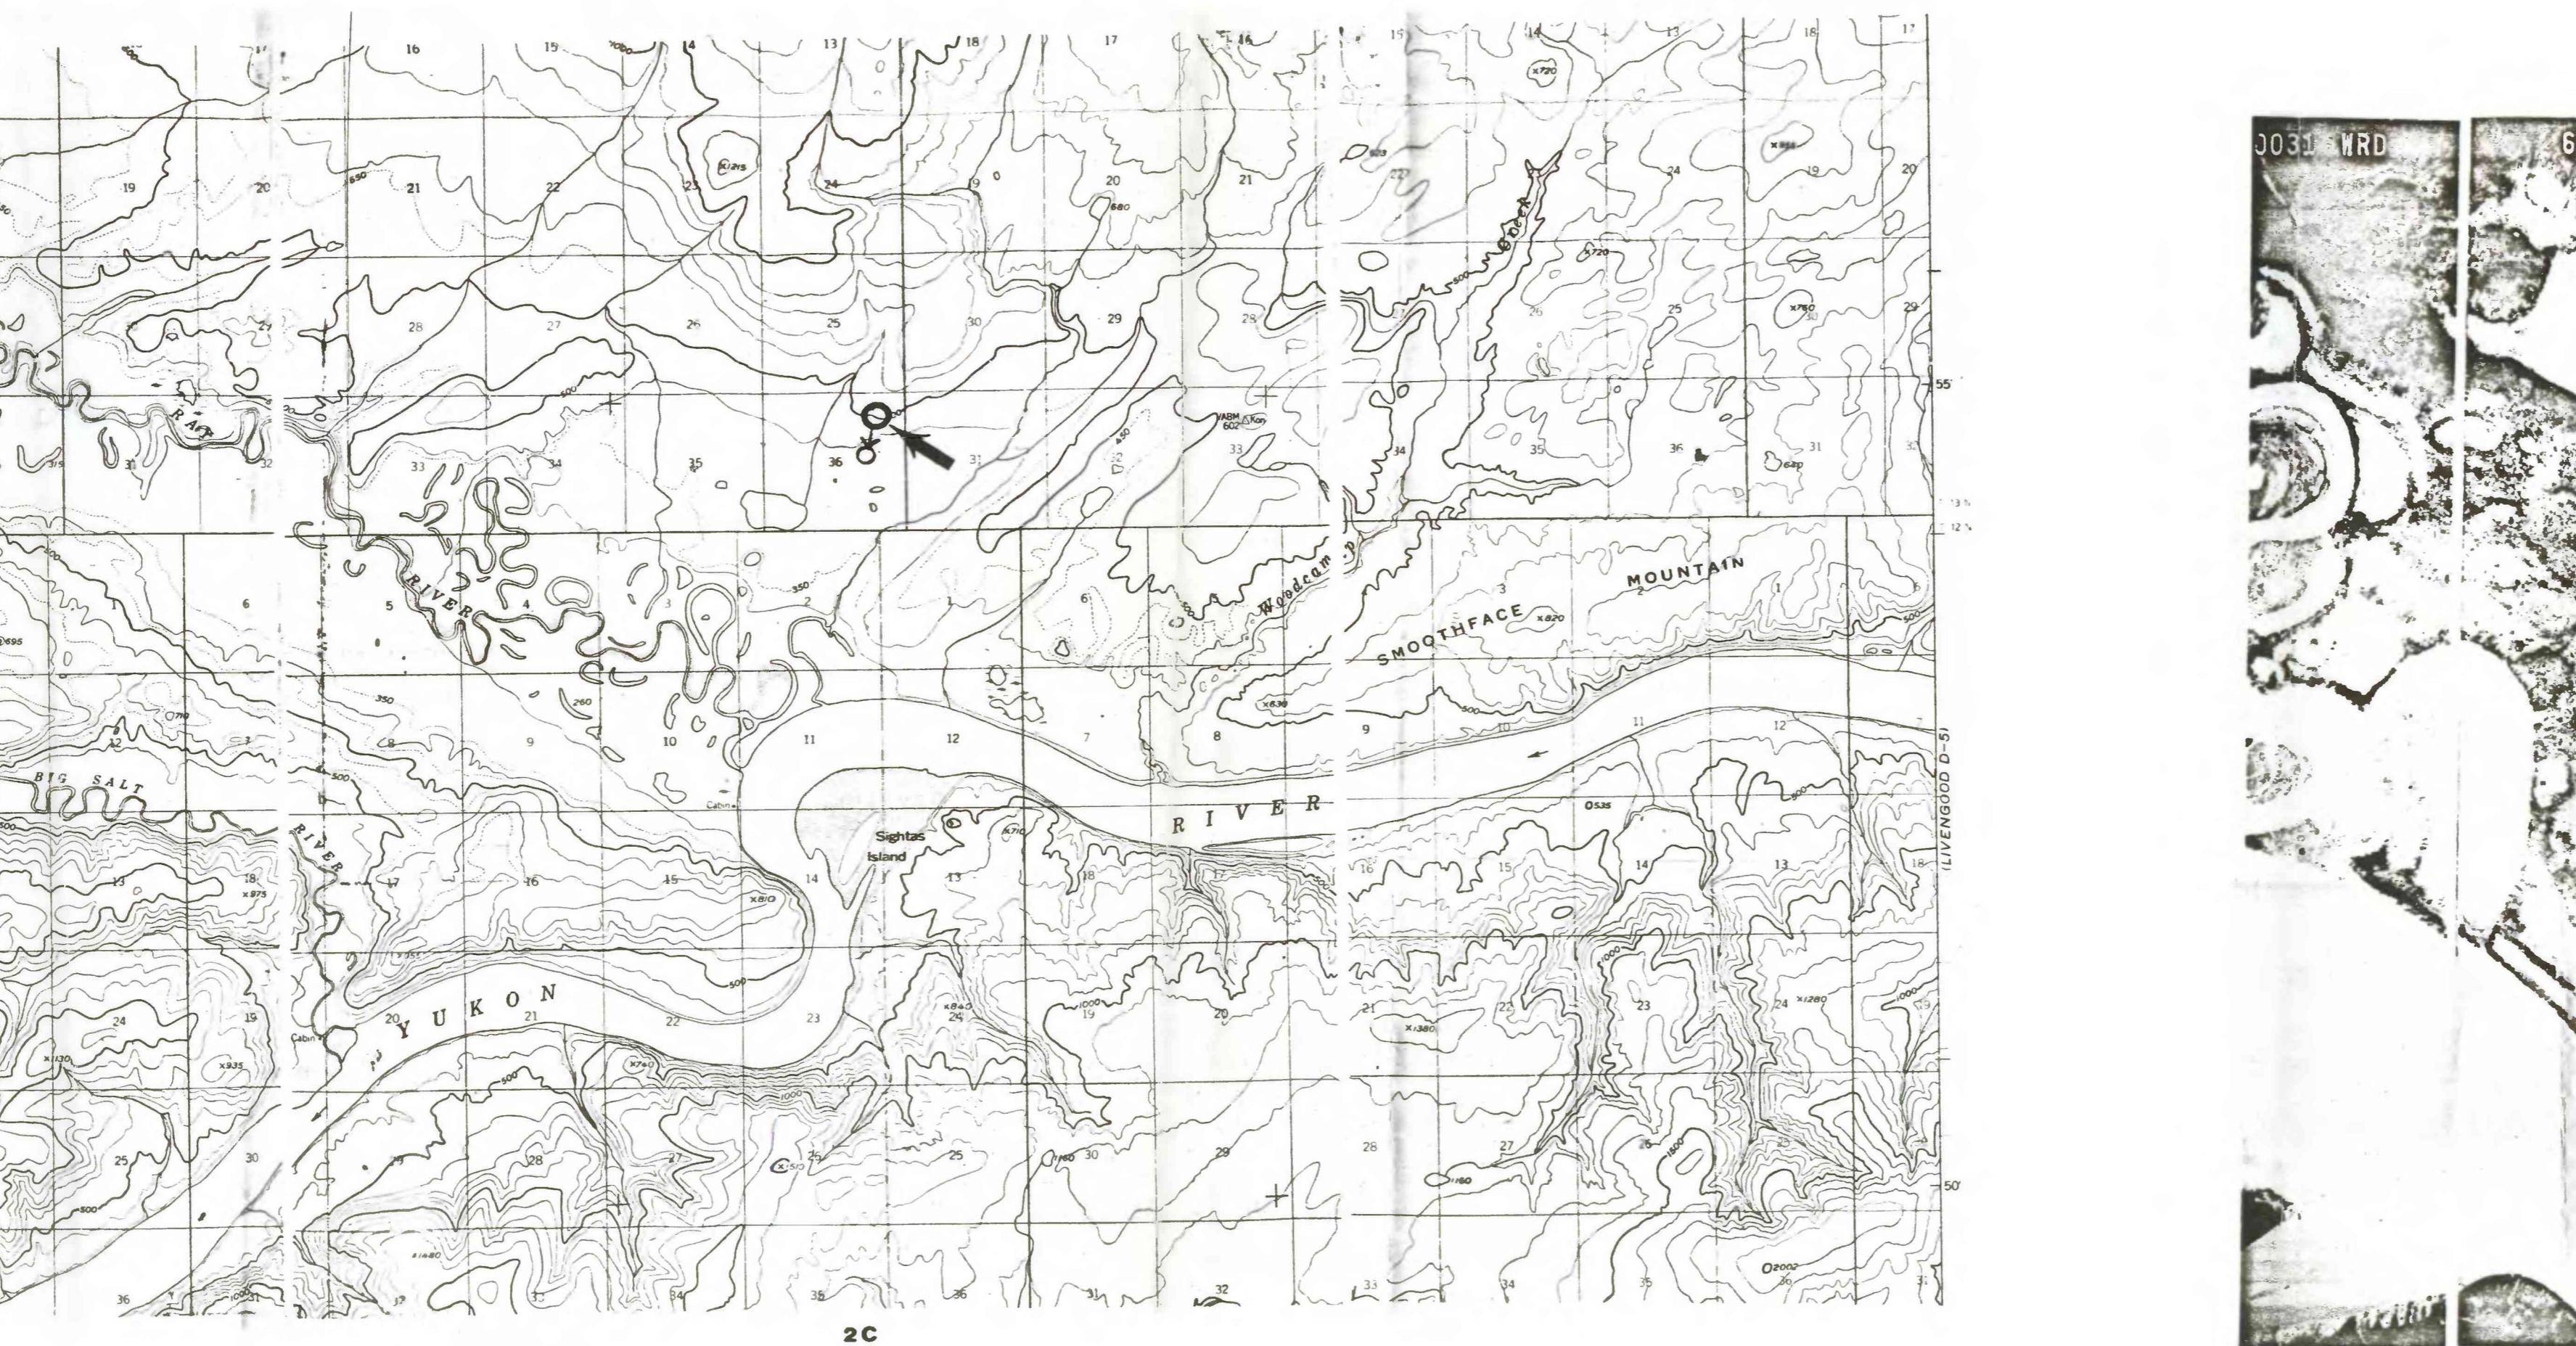
Figure 2C. Livengood D-6 quadrangle sheet showing area of icing in section 36 T13N R11W.
